# The Advanced Photon Source RF Systems

## *-- Performance and Upgrades – 2012-2014*

Doug Horan  
Advanced Photon Source  
RF Group  
ASD Seminar  
November 12, 2014

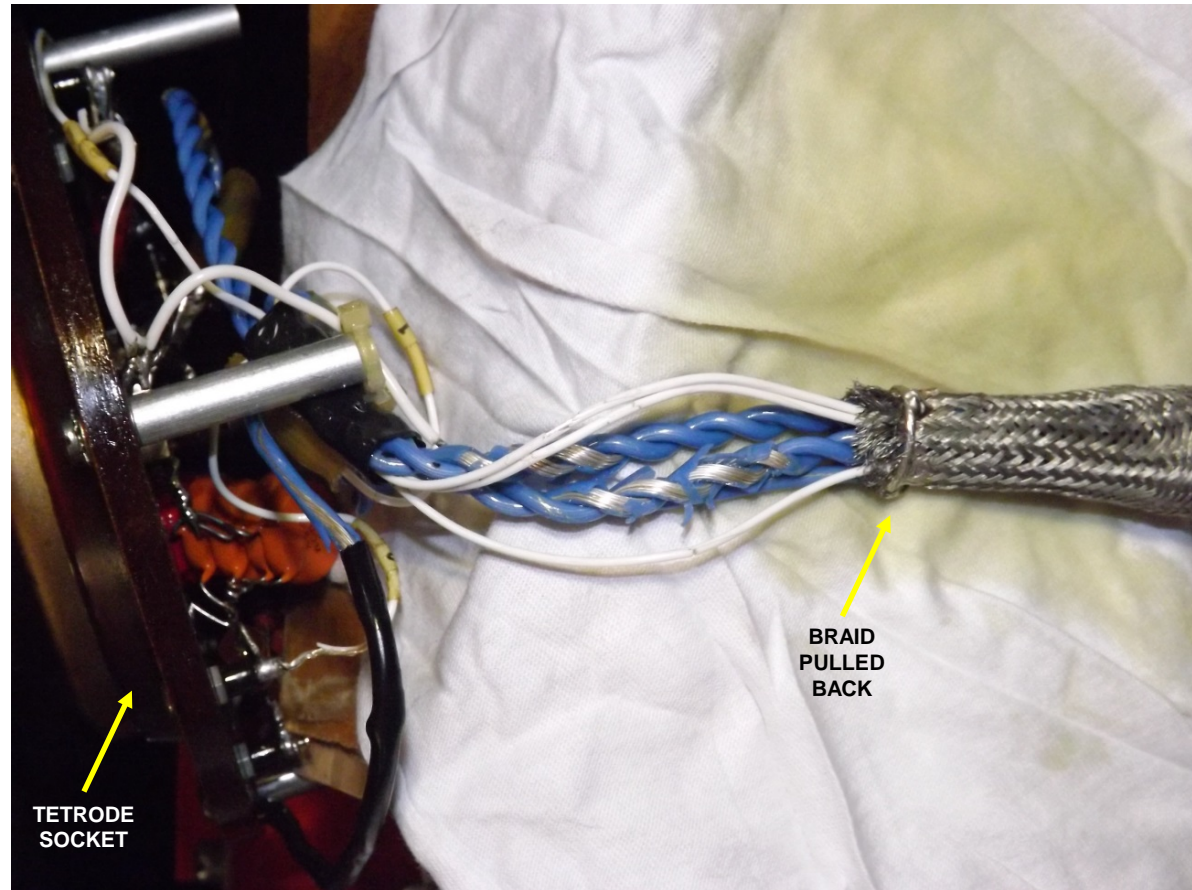
# Intermittent Loss of Mod-Anode Voltage Regulation – *cause of many beam losses*

- 18 years of X-rays from tetrodes damaged teflon wire used to feed heater power to the tetrodes
- Caused intermittent short circuit of heater power
- Damage found in all rf stations
- Wiring was replaced

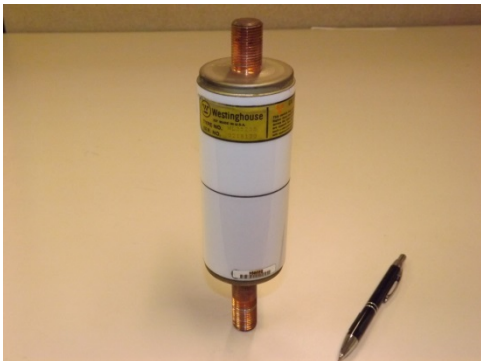
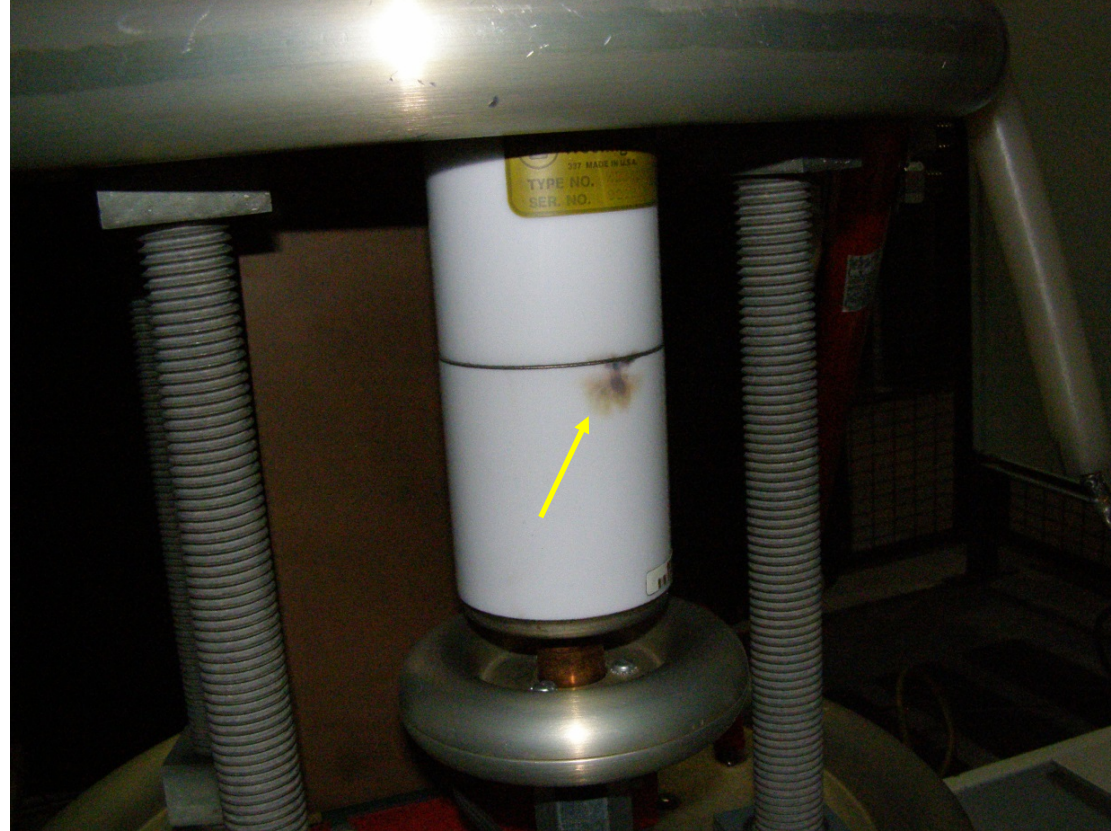
# Cause of Crowbar Trips – *Failed 50kV Vacuum Switch*

- Two 50kV switches used in series at low end of crowbar test wire
- Switch breaks down in open position, causing intermittent crowbar trips
- No longer available from original manufacturer – found second source

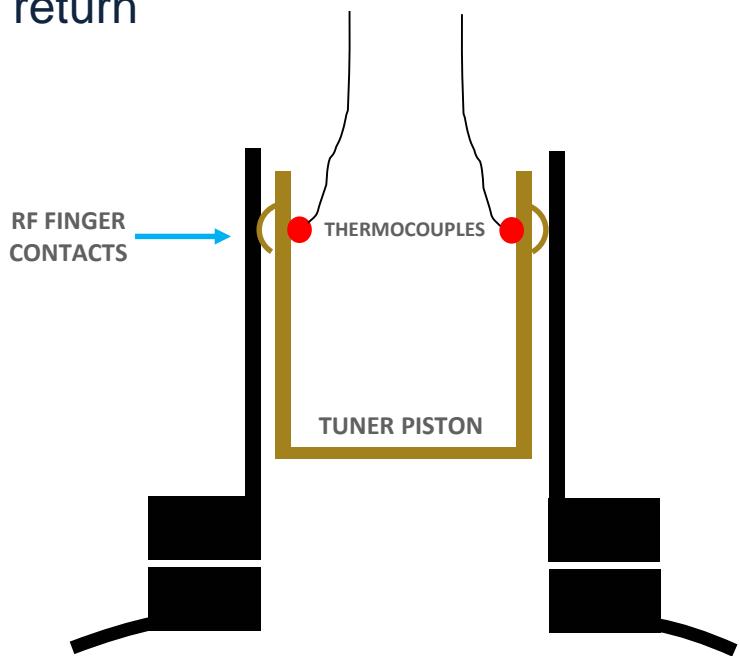
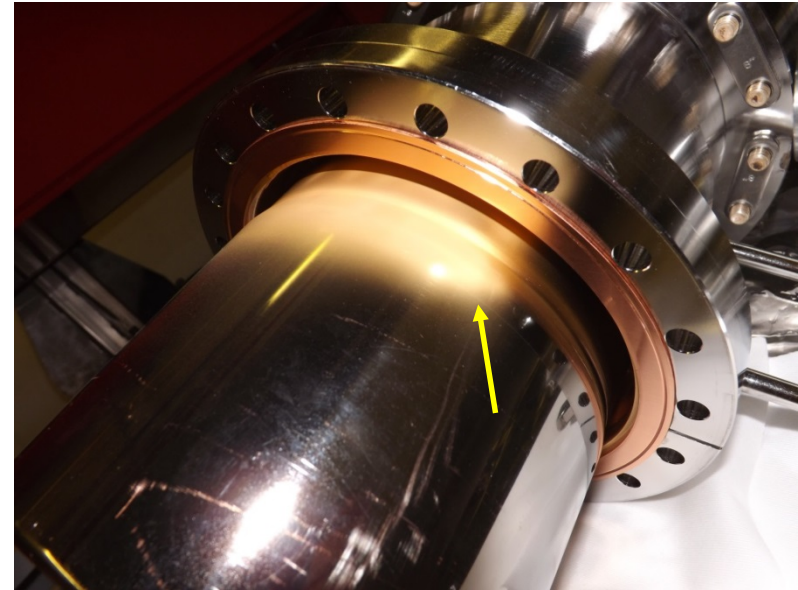
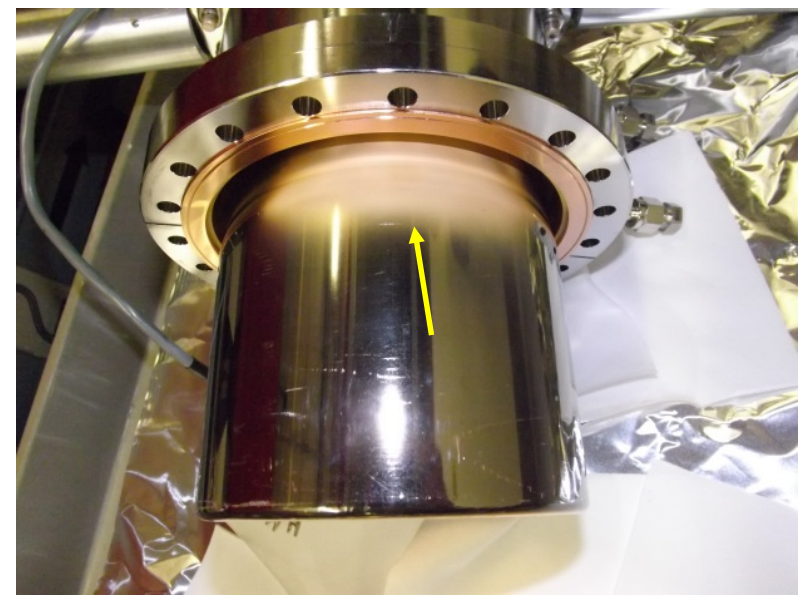
# Sector 36/Cavity #3 “Hot Tuner”

- RF Finger temperature suddenly 25-40°C warmer with hybrid fill pattern – *but normal with 324 singlets*
- Tuner inspection at shutdown shows “plating” on piston.....*gold?*
- Tuner was replaced.....problem didn't return

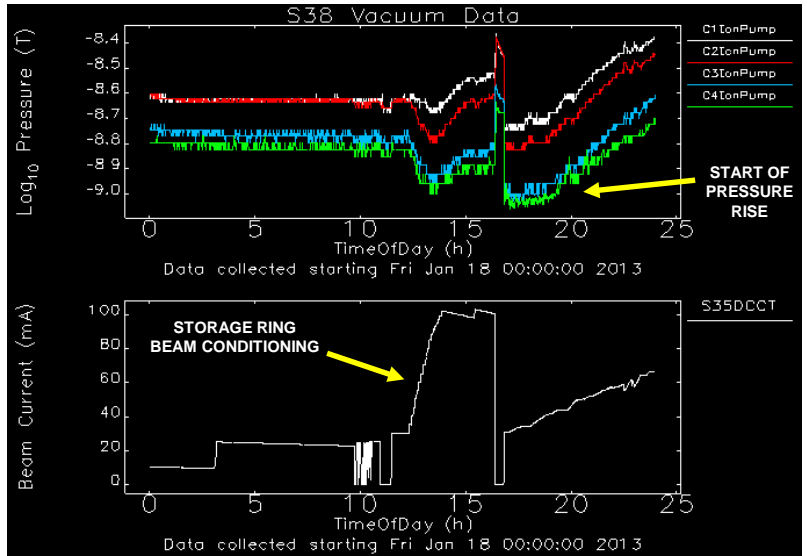
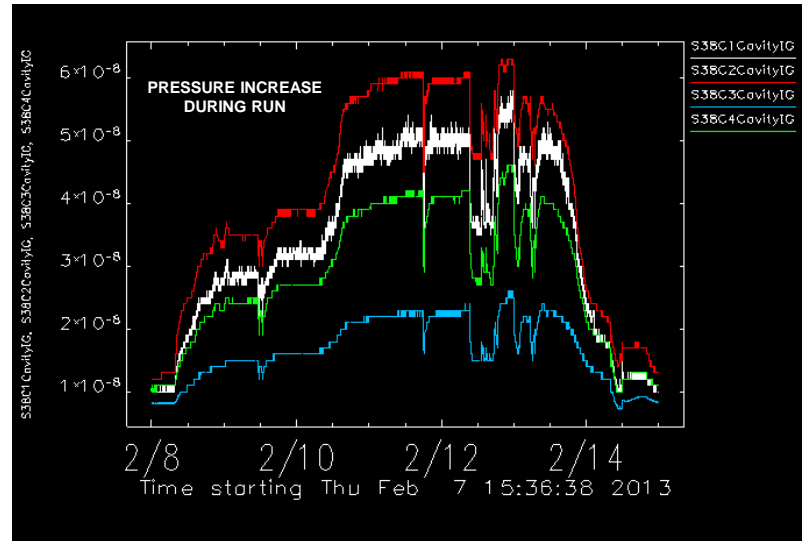
# Sector 38 RF Cavities – Mysterious Vacuum Problem

- Vacuum pressure in entire sector of cavities started to rise suddenly at the end of post-shutdown beam conditioning -- *highest pressure in cavity 2*
- Pressure continued to rise as the run progressed, and vacuum interlock trip points had to be raised to stay in operation
- Multiple helium leak tests showed no leaks from atmosphere
- Residual gas analyzer indicated traces of chlorine and fluorine
- Tried conditioning during shutdown, but pressure eventually increased to the point that we could not run rf

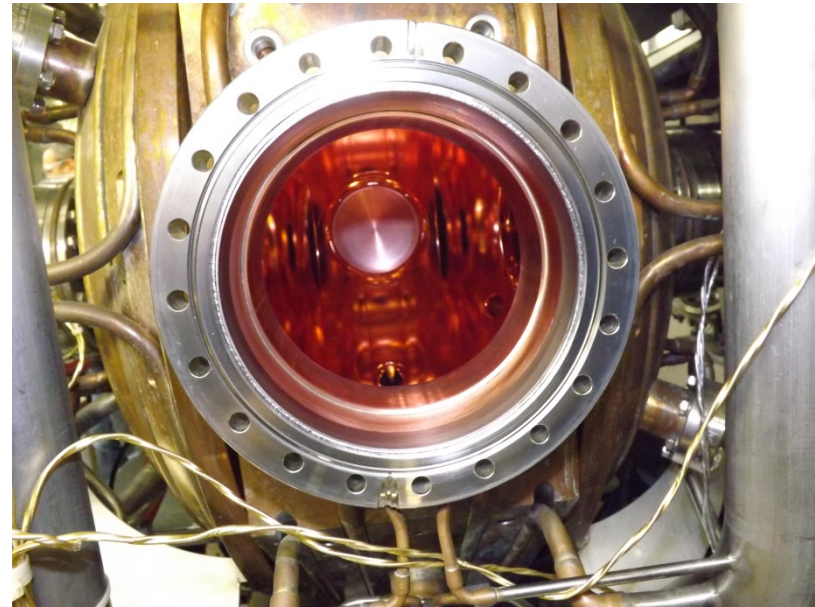
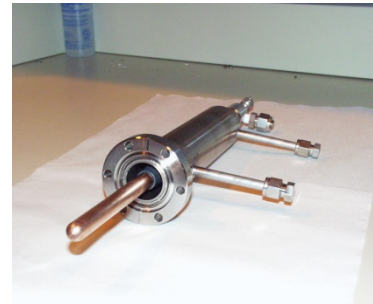
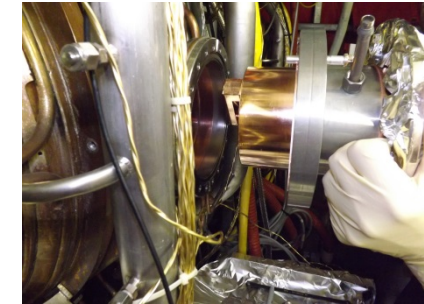
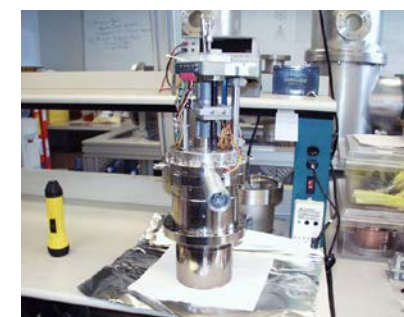
# Sector 38 RF Cavities – *Mysterious Vacuum Problem*

- Parts were “*shot-gunned*” – Couplers, tuners, and HOM dampers were removed from cavities 1 and 2 – *all parts except for one HOM damper were replaced with new components*
- Vacuum pressure quickly returned to normal levels -- low-mid E-9 Torr
- Cavities were re-conditioned back to operating levels in approximately three days
- Pulled parts were installed in RF Test Stand cavity individually to determine which component was outgassing
- Cavity #2 tuner was the source of gas

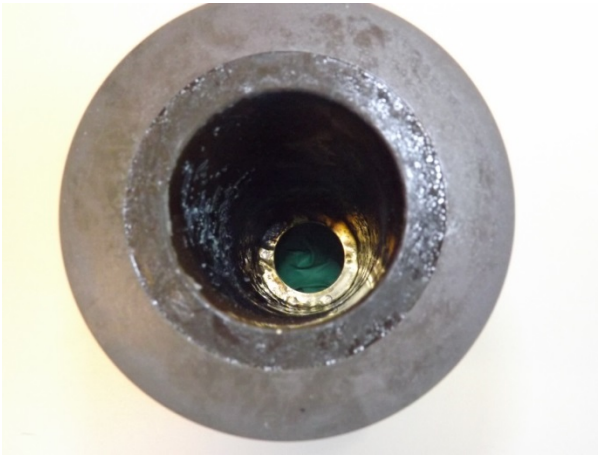
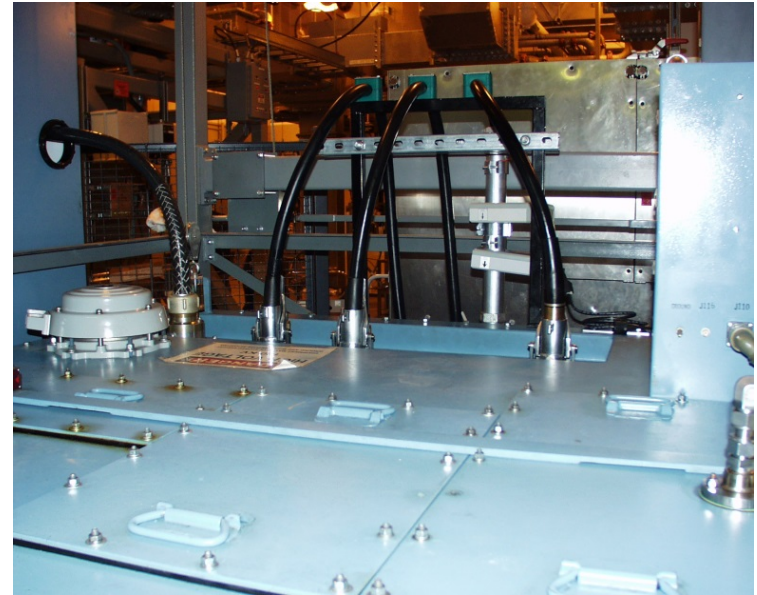
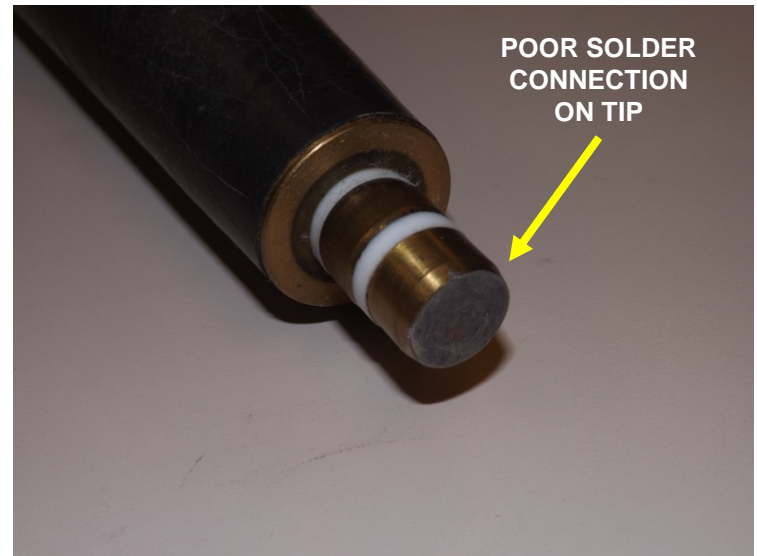
# High-Voltage Cable/Socket Failures

- Connector arcing causes crowbar trip and damage to plug and socket

- **Causes:**

- Plug insertion force too low
- Foreign objects in socket
- Insufficient insulating grease
- Intermittent contacts on plugs

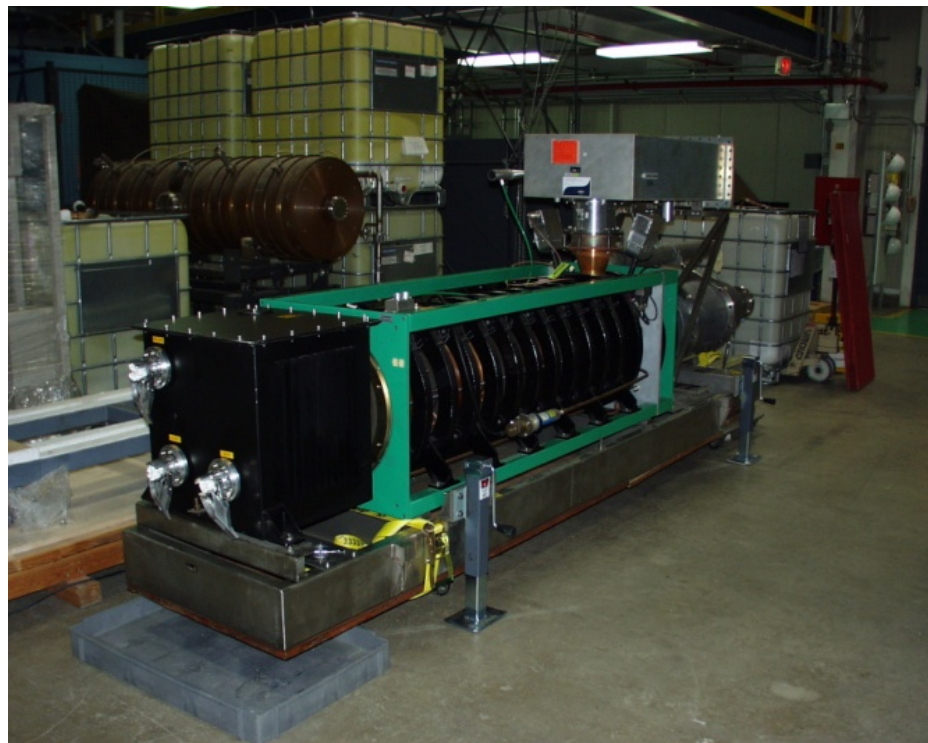
EEV s/n 01 REMOVED FROM RF3

# Multiple Problems with RF3

## *Trouble Started With a Klystron Change!*

- **Longest living klystron at APS was retired at RF3:**
  - EEV K3513 s/n 01
  - Retired at 81,209 filament hours
  - 14 years of service with no problems or instabilities
- Replaced with rebuilt spare
- Immediate issues with poor efficiency, crowbar trips, and sideband instabilities
- RF3 was unavailable for an entire run while troubleshooting was in progress
- Multiple causes found:
  - *Significant cathode voltage readback error*
  - *Intermittent HV connectors*
  - *Waveguide arcing*

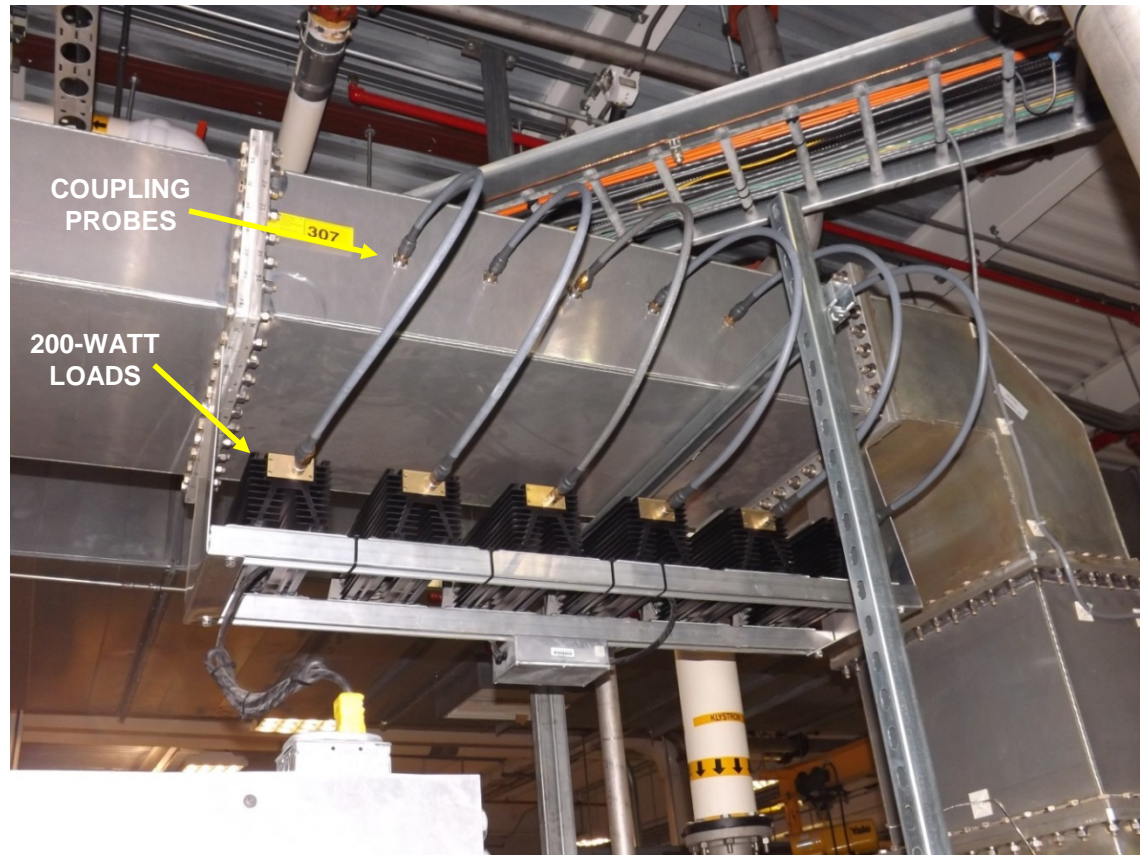
**2<sup>nd</sup> HARMONIC DAMPER AT RF3**

# Waveguide Arcing at RF3

- Using the EEV klystron, the system would run at  $\approx 700\text{kW}$  for almost an hour, then trip on waveguide arc
- Loud noises coming from the 2<sup>nd</sup>-harmonic damper
- After four or five arc trips to gather data, we shut the system down
- Waveguide was dismantled for inspection during the maintenance shutdown

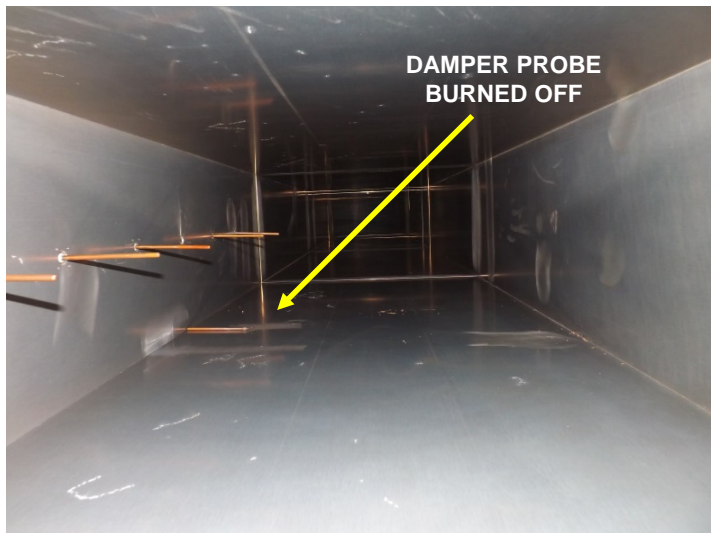
**ARCING DAMAGE TO HARMONIC DAMPER PROBES**

**Severe damage to harmonic damper pickup probes and terminating loads**

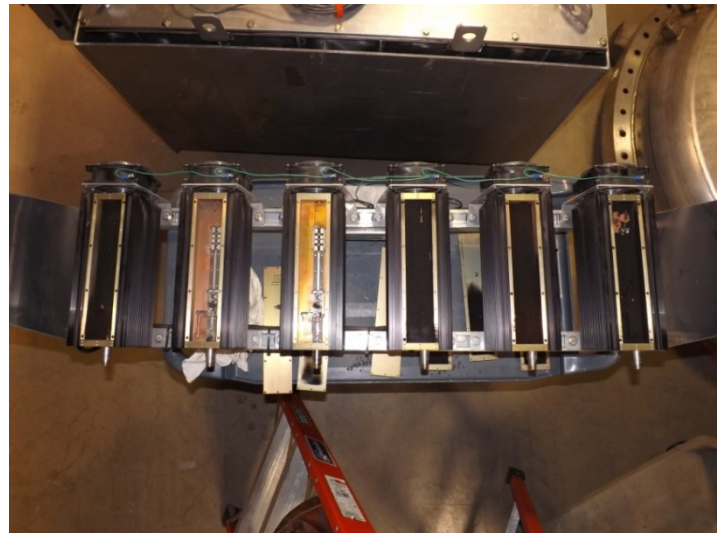
**ALL SIX HARMONIC DAMPER LOADS DESTROYED**

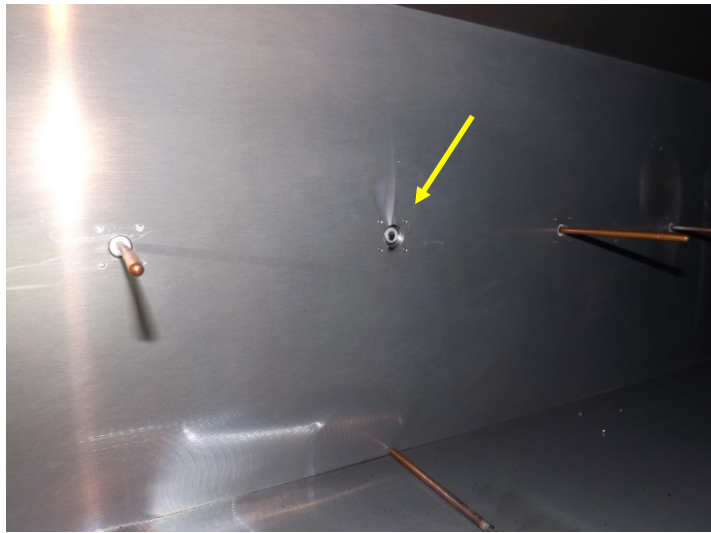
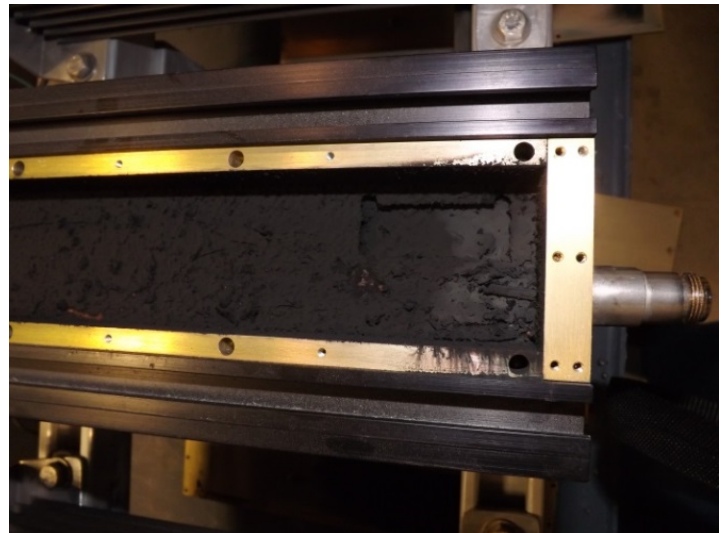
**Cause: Excessive 2<sup>nd</sup> harmonic output from klystron**

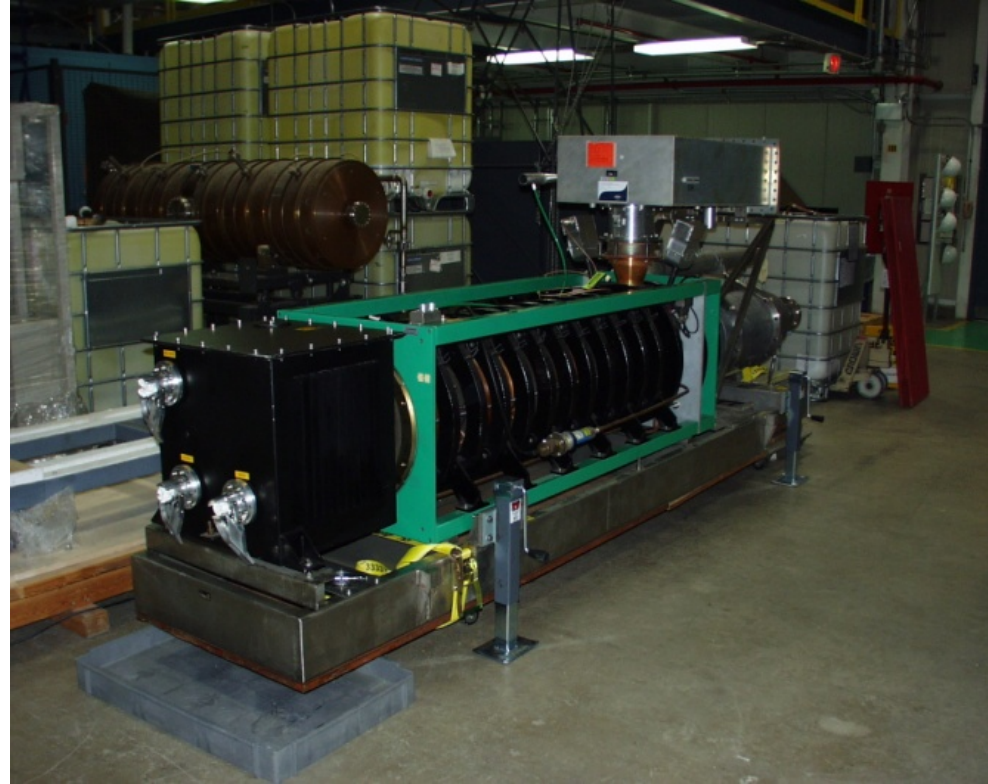
# EEV s/n 01 Caused Waveguide Arcing at RF3

- EEV s/n 01 was brought out of retirement and re-installed in RF3 to help troubleshoot system
- Klystron produced excessive 2<sup>nd</sup>-harmonic power.....why?
- Klystron rf cavity tuning nuts were found to be loose on cavities 3 and 4
- EEV s/n 01 retired permanently!
- Replaced with new Thales klystron s/n 089048
  - *Efficiency at 650kW output is ~ 4-5% lower than other Thales klystrons*
  - *Some sideband instabilities, but avoidable with careful adjustment*

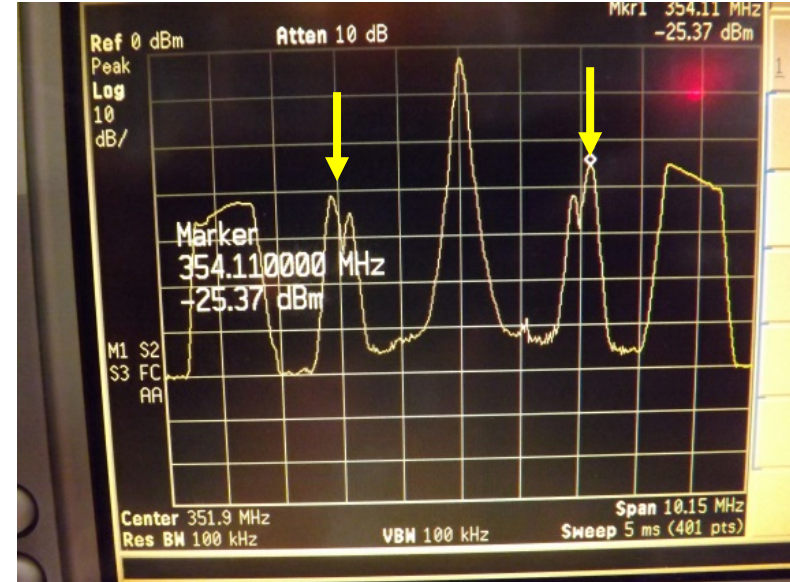
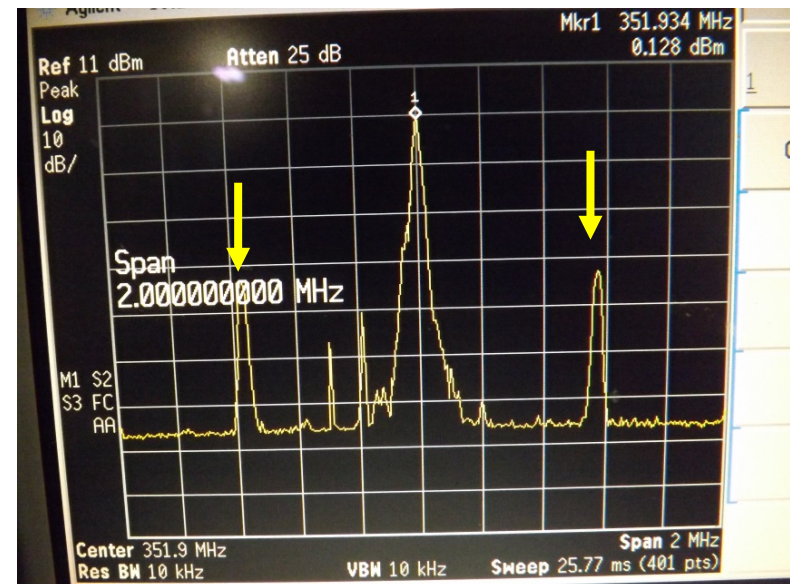
# Klystron Sideband Instabilities

- A common problem with Thales TH2089A
- Two types:
  - *Back-streaming electrons* -- Thought to be caused by back-streaming electrons from the collector accelerated towards the cathode by output cavity gap voltage. Sideband frequency is typically  $351.93\text{MHz} \pm$  the difference between resonant frequency of cavity 1 and cavity 2:  $\approx \underline{2.2\text{MHz}}$  →
  - *Cavity multipactor* – Caused by multipactor in the first or second rf cavities. Sideband frequency is typically  $351.93\text{MHz} \pm 1\text{MHz}$  or less →
- Sidebands can exist at fixed frequencies, or drift in frequency randomly
- Can be controlled by careful adjustment of cathode voltage, output match (circulator bias), and rf drive level

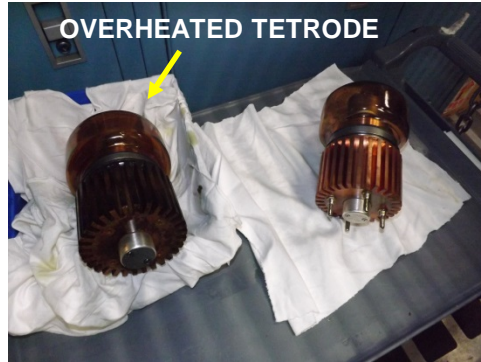
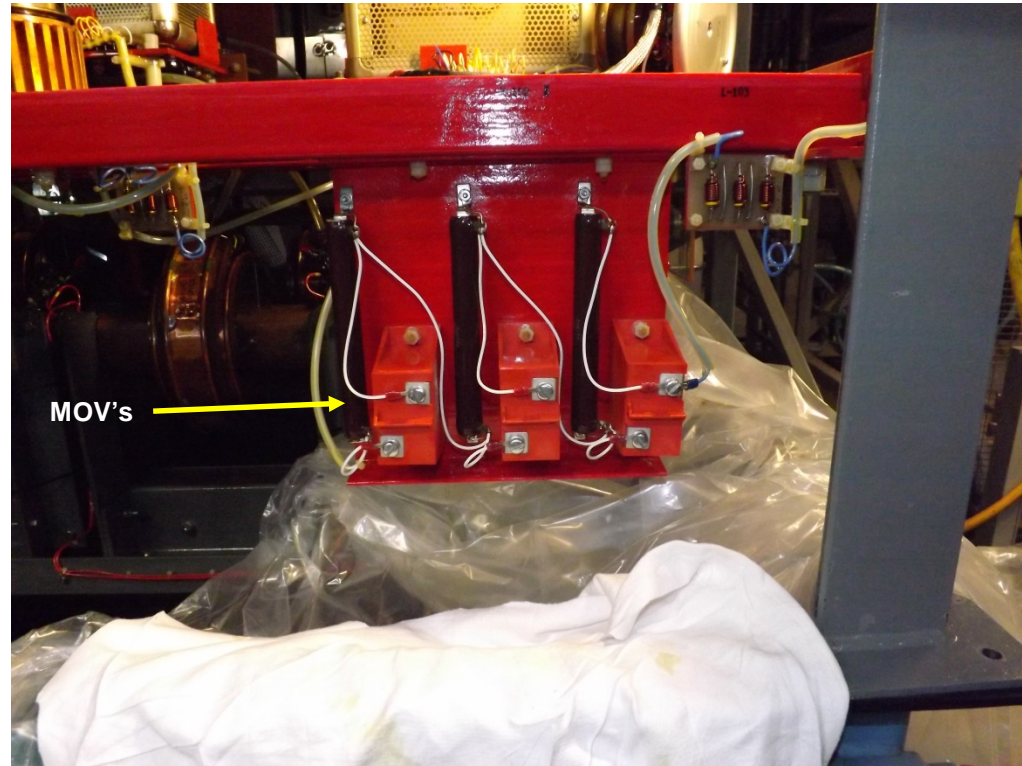
# Shorted MOV in Mod-Anode

- The shorted MOV effectively reduced the plate load resistance of one tetrode from 225k $\Omega$  to  $\approx$  22k $\Omega$

- The power dissipated by the tetrode began to heat the 400 gallons of oil in the tank.....until the system tripped on a “mod anode overtemp” fault

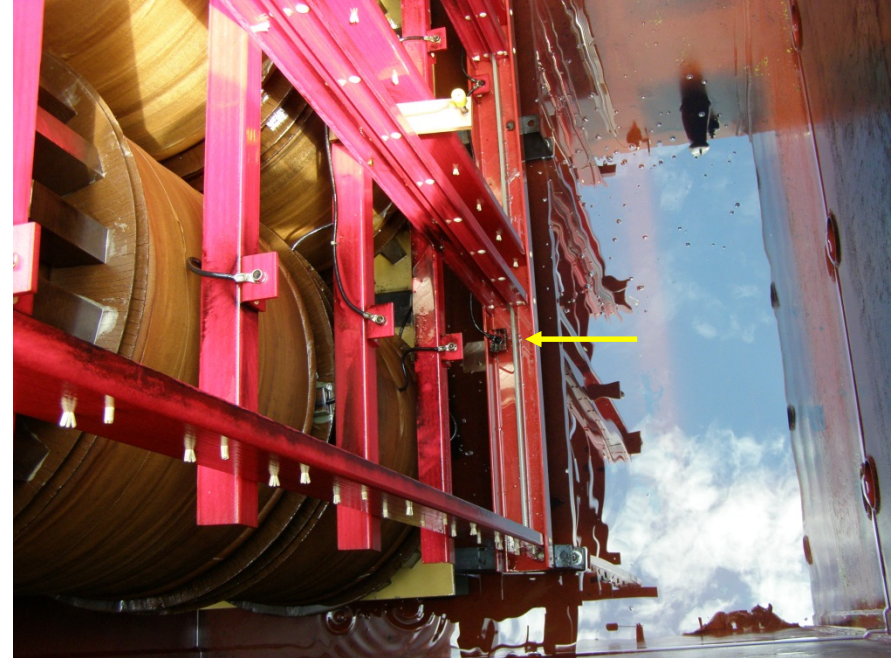
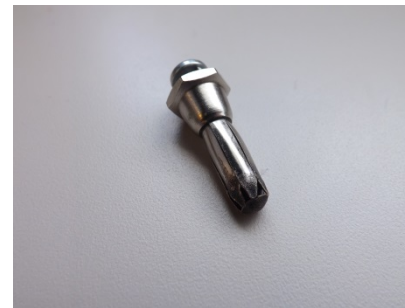
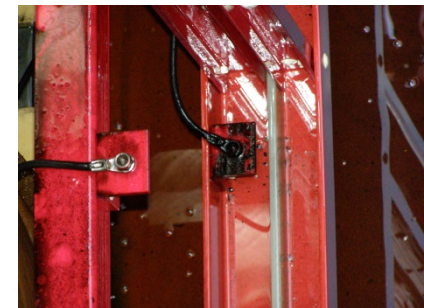
# Failed Banana Plug Connection in RF3 Transformer-Rectifier Set

- During routine maintenance, trace chemical analysis of the T-R set oil detected chemical markers for arcing in the oil
- Problem traced to a partially-inserted banana plug used as the bottom connection to a rectifier stack, located under 3,000 gallons of insulating oil
- The plug eventually overheated and began arcing under load

**DAMAGED PLUG AND MATING SOCKET**

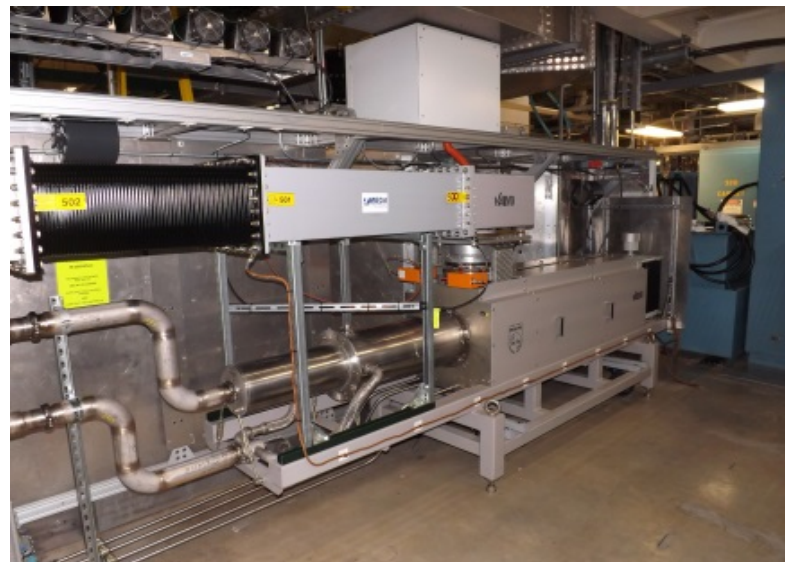
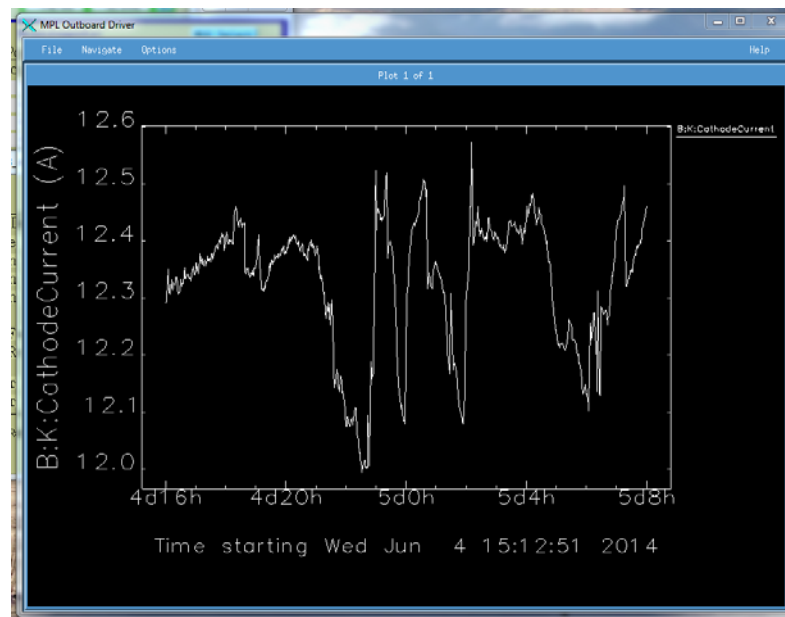
# Failure of Re-tuned Philips YK1350 Klystron in RF5

- Retired from CWDD project in 1995
- Re-tuned from 352.21MHz to 351.93MHz in 2009 and tested to 1MW cw in test stand with no problems
- Installed at RF5 in January 2014
- Operated normally for first run of 2014 with no problems
- Coming out of the May 2014 maintenance shutdown, the klystron beam current became unstable
- All attempts to stabilize the gun perveance were futile
- The Philips klystron was removed from RF5 in June 2015 -- the original klystron was re-installed

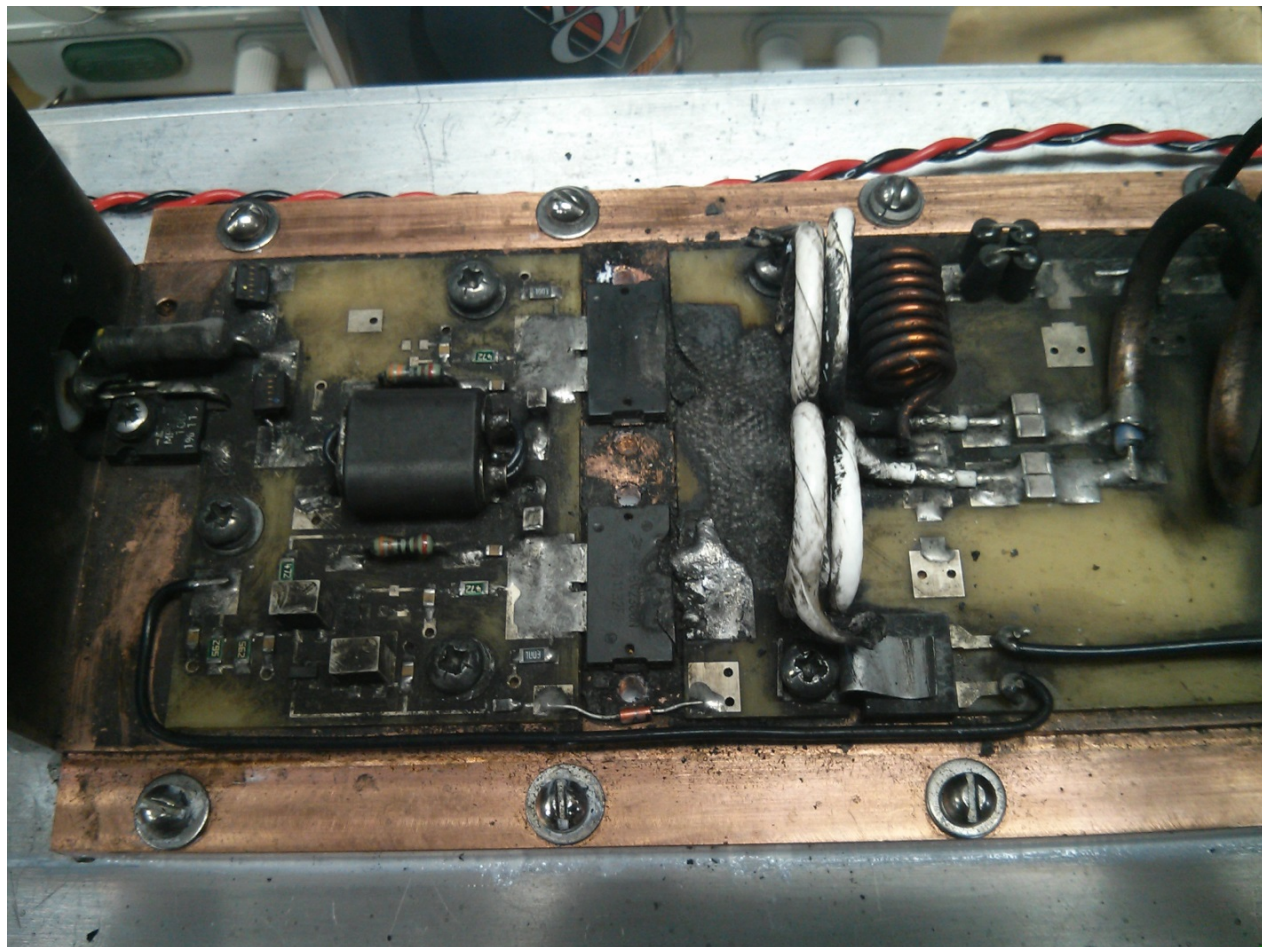
# Harmonic PAR Driver Amp Failure

- 117.3MHz/500-watt cw commercial amplifier
- Failed during bench testing into load
- Input and output leads were disconnected with dc power applied
- Suspected instability in design
- Not repairable

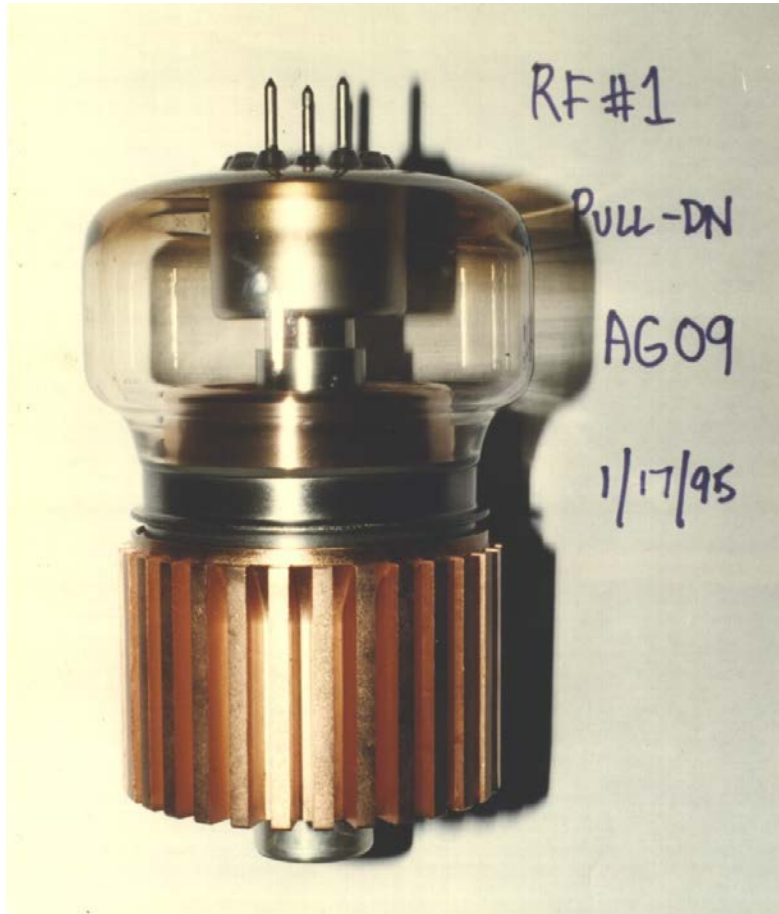
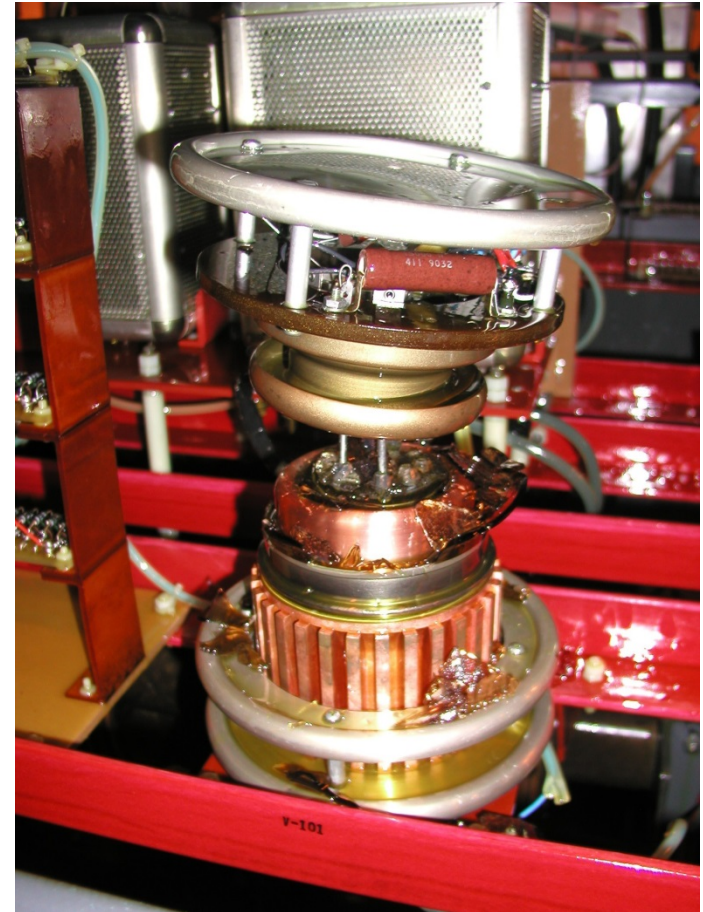
# Destruction of a Mod-Anode Tetrode Tube Due to a Malfunctioning Crowbar

**CROWBAR FAILED TO FIRE IN RESPONSE TO A HIGH VOLTAGE FAULT**

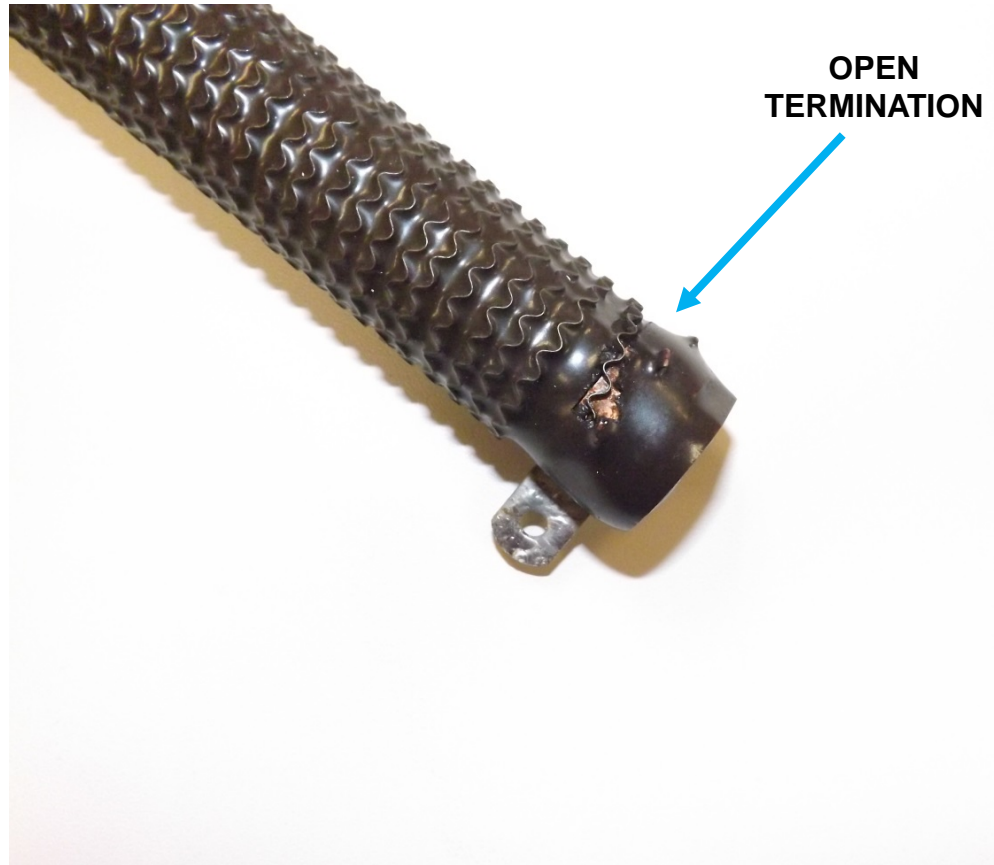
# T-R Set Resistor Failure

- Found during routine measurement of RF4 capacitor bank
- Measured  $7.5\mu\text{F}$  rather than expected  $8.1\mu\text{F}$
- Found resistor in series with capacitor open on one end
- Failed due to age, temperature, crowbar event stress, oil.....???

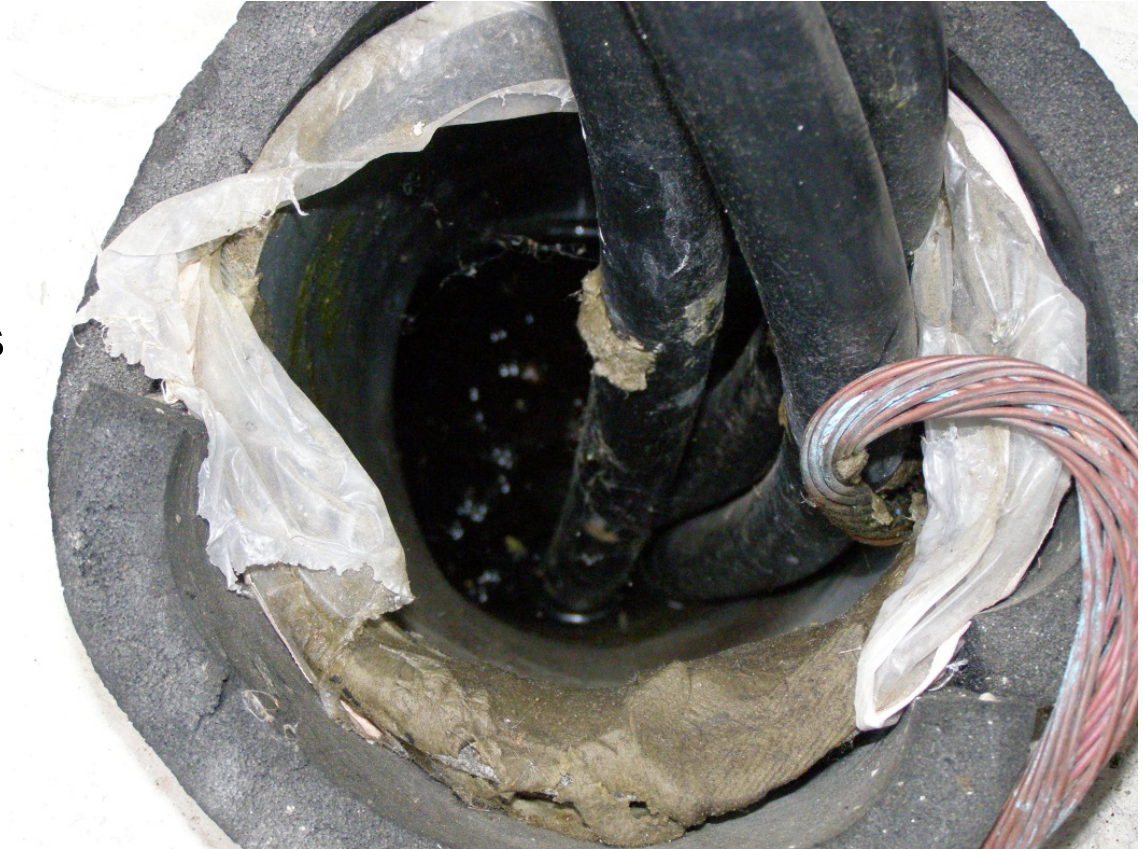
# Potential Problem?

## -- *Water in 13.2kVAC and 1400VAC Underground Conduits*

- Conduits run between outdoor transformer pads and rf building
- Cables are almost 20 years old
- Possible failure due to freeze-thaw stress?

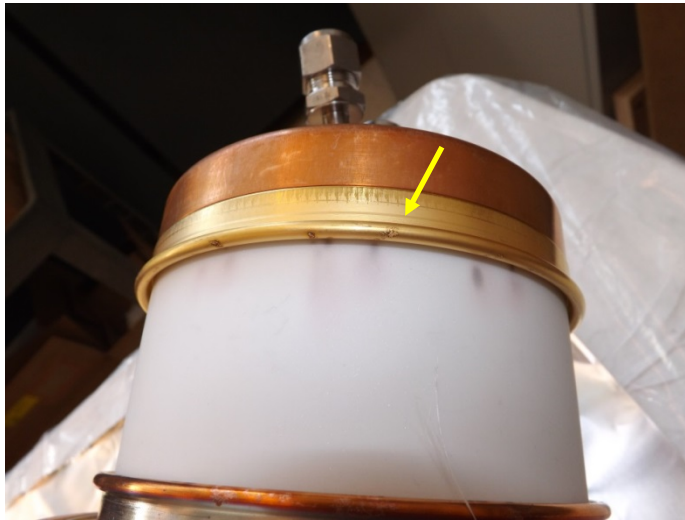
- Design goal for APS is 200kW cw power handling capability
- Prototype reached 200kW cw in APS RF Test Stand
- Evidence of minor arcing on ceramic noticed after test:

- Analysis underway to determine the cause of the arcing and solve the problem
