S:IS1 THICK SEPTUM REPLACEMENT AND RECOVERY

JOHN CONNOLLY
Deputy ALD for Operations, PSC
Division Director, AES

September 30, 2019
Updated October 8, 11, 18 and 22, 2019

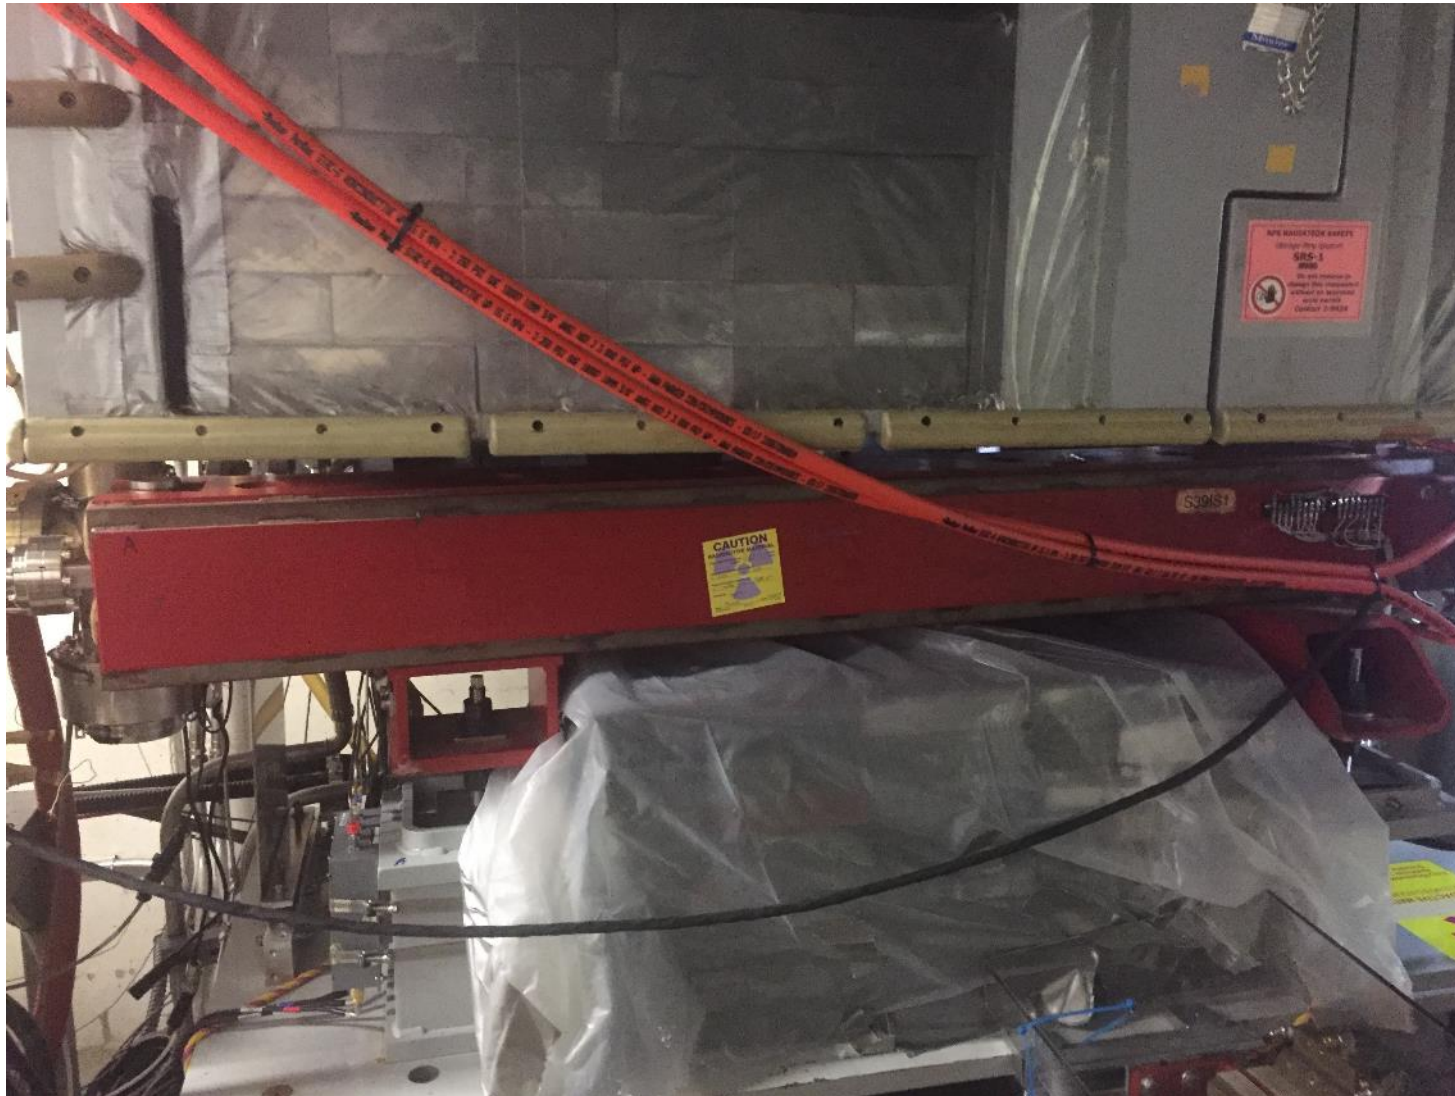
On-hand spare injection septum installed as of evening of Oct 9

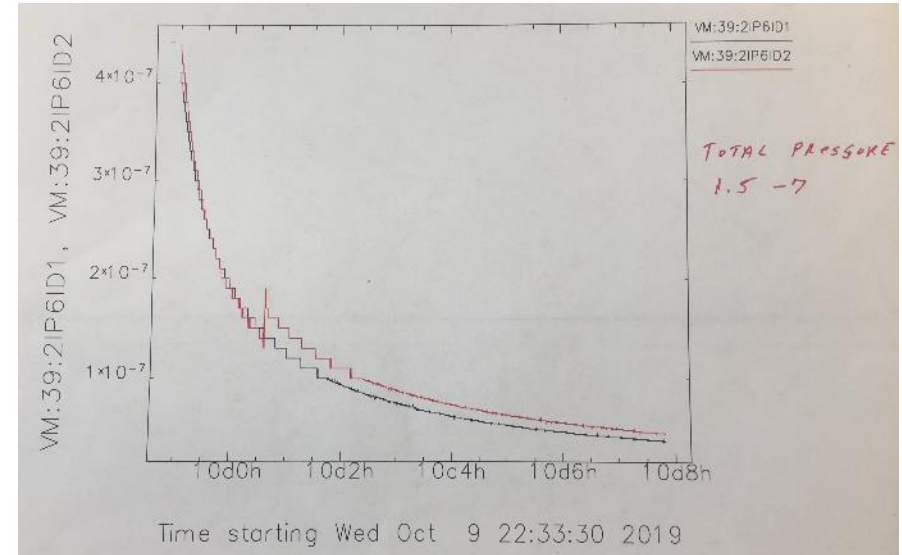
Minimum vacuum for injection achieved by morning Oct 10

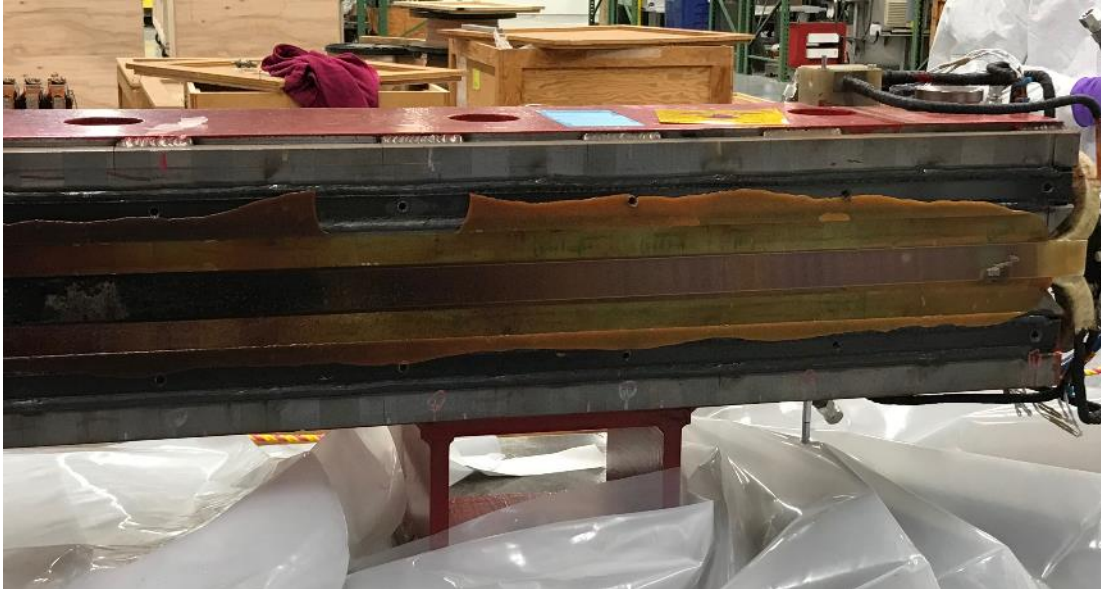
Discoloration noted in magnet coil/epoxy assembly after side plate removed on first failed injection septum magnet

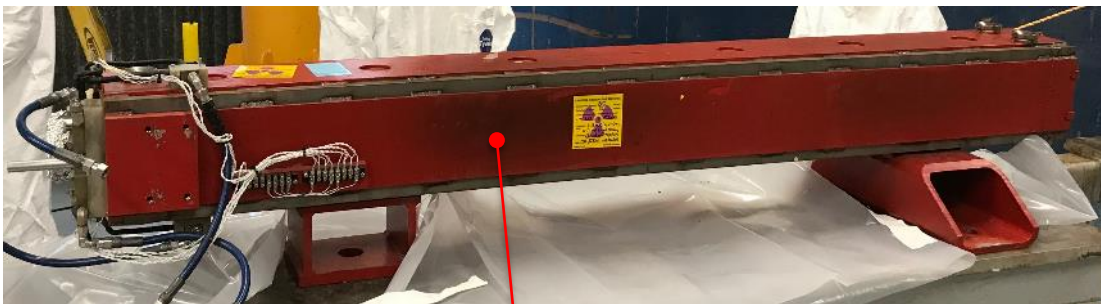
Discoloration noted on plate opposite of removed side plate, on first failed injection septum magnet

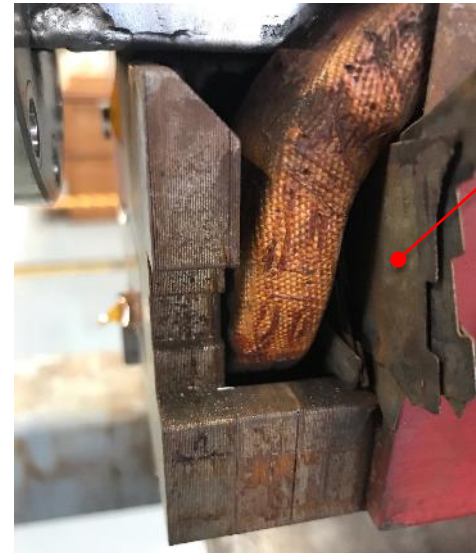
Loose laminations as-found on first failed septum

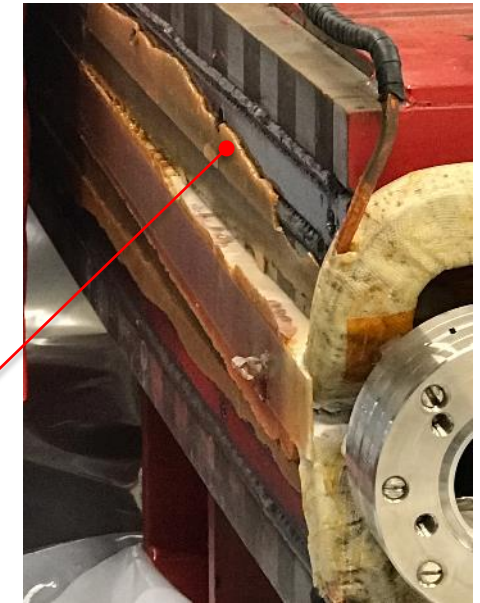
Mechanical separation of epoxy from magnet core

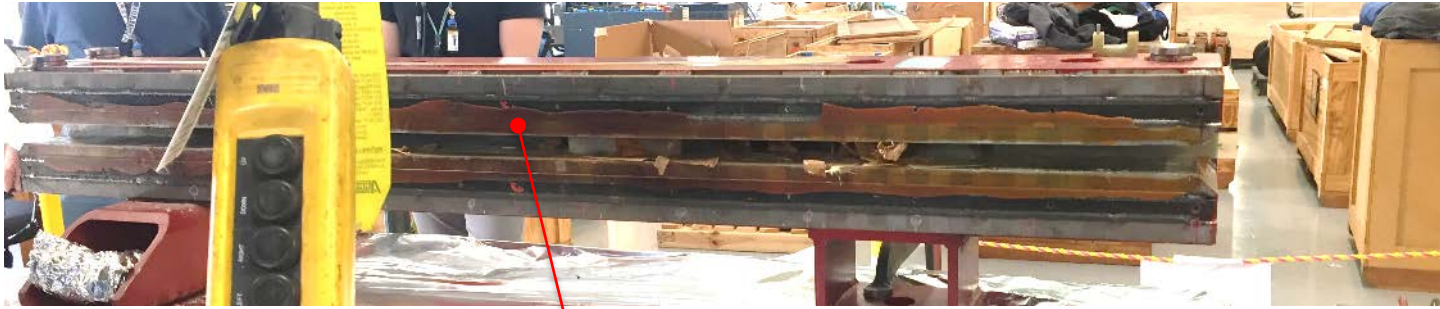
Discoloration with magnet coil, epoxy, chamber removed from core

Separation of laminations and discoloration corresponding to location in image above

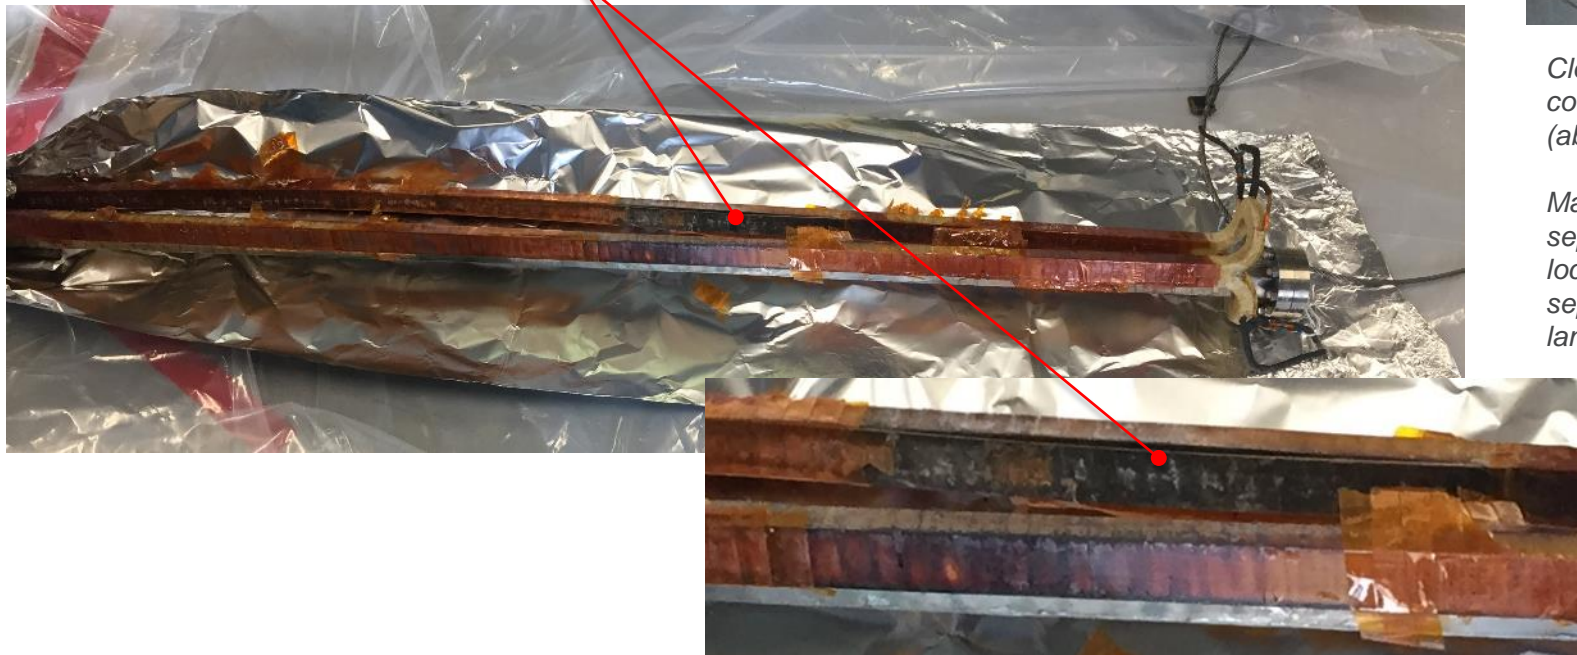
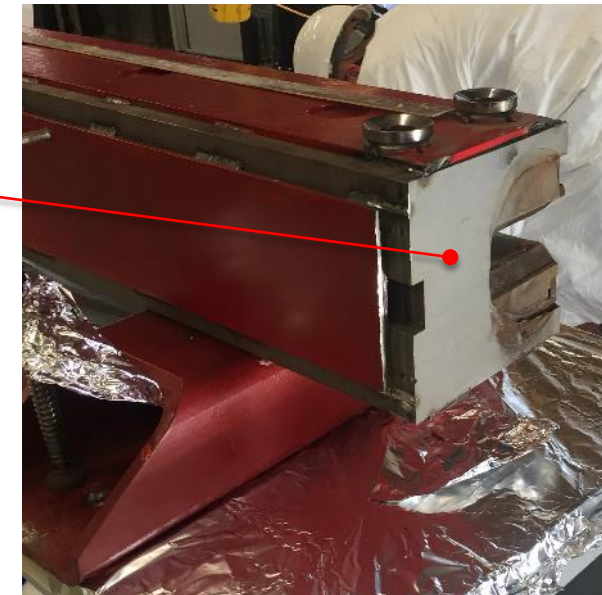
Machined end of septum, showing location of separated, broken laminations

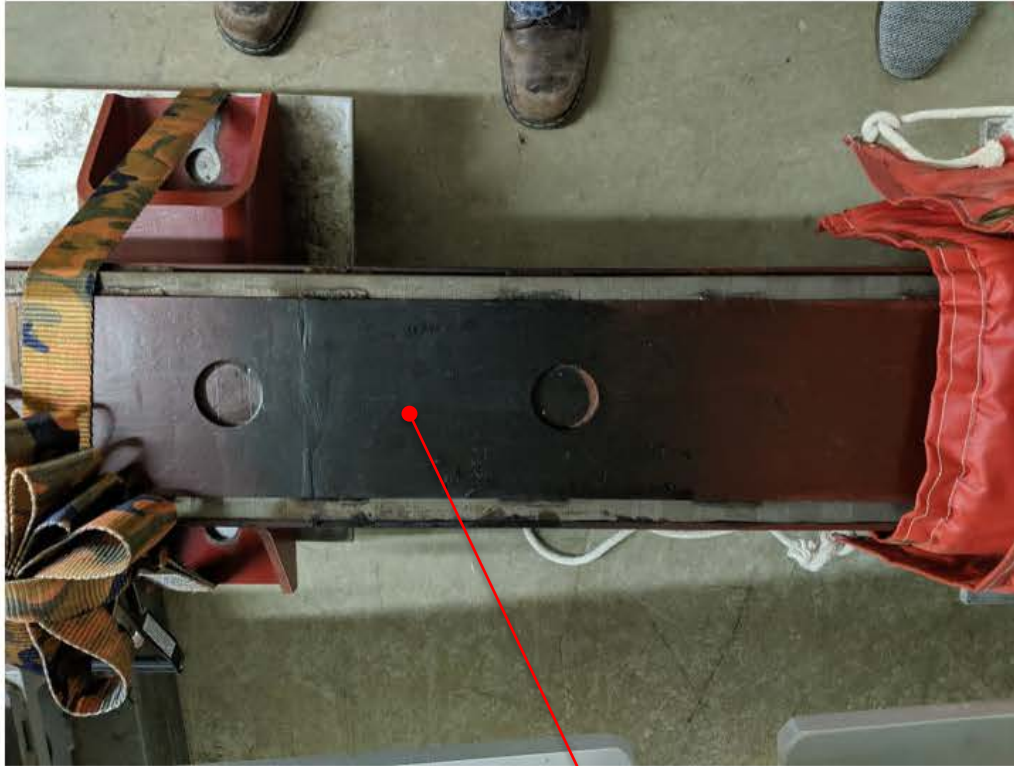
Significant discoloration on top of downstream end second failed injection septum, as found after removal and placement in Storage Ring tunnel

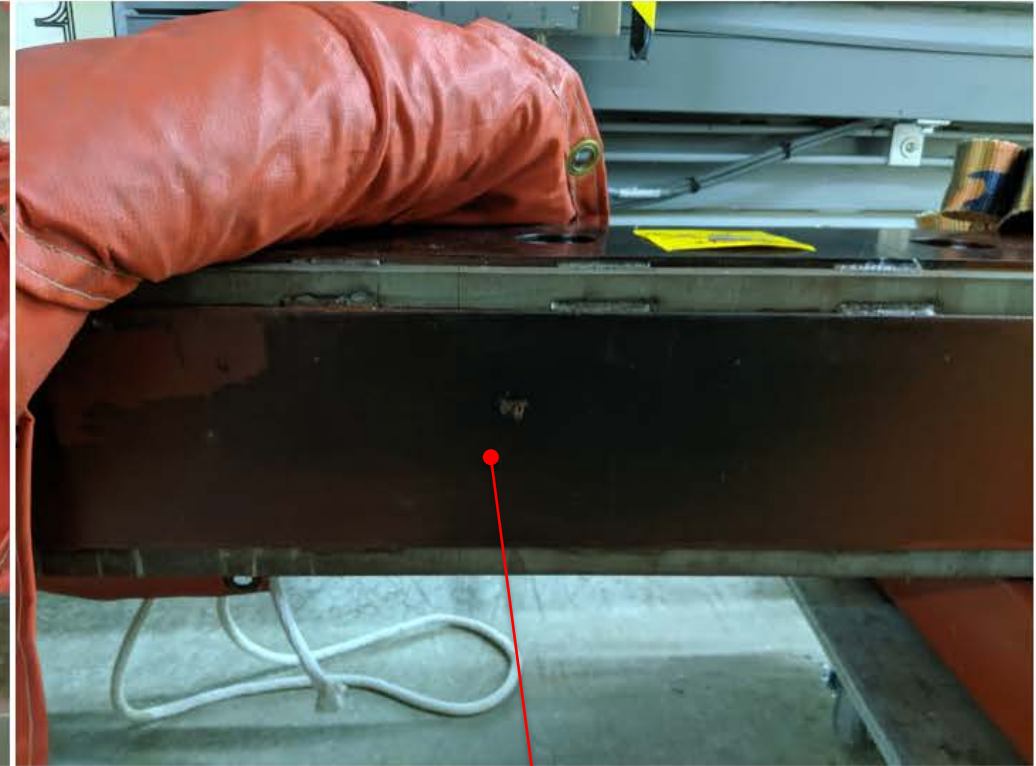
Significant discoloration noticed on side of second failed injection septum

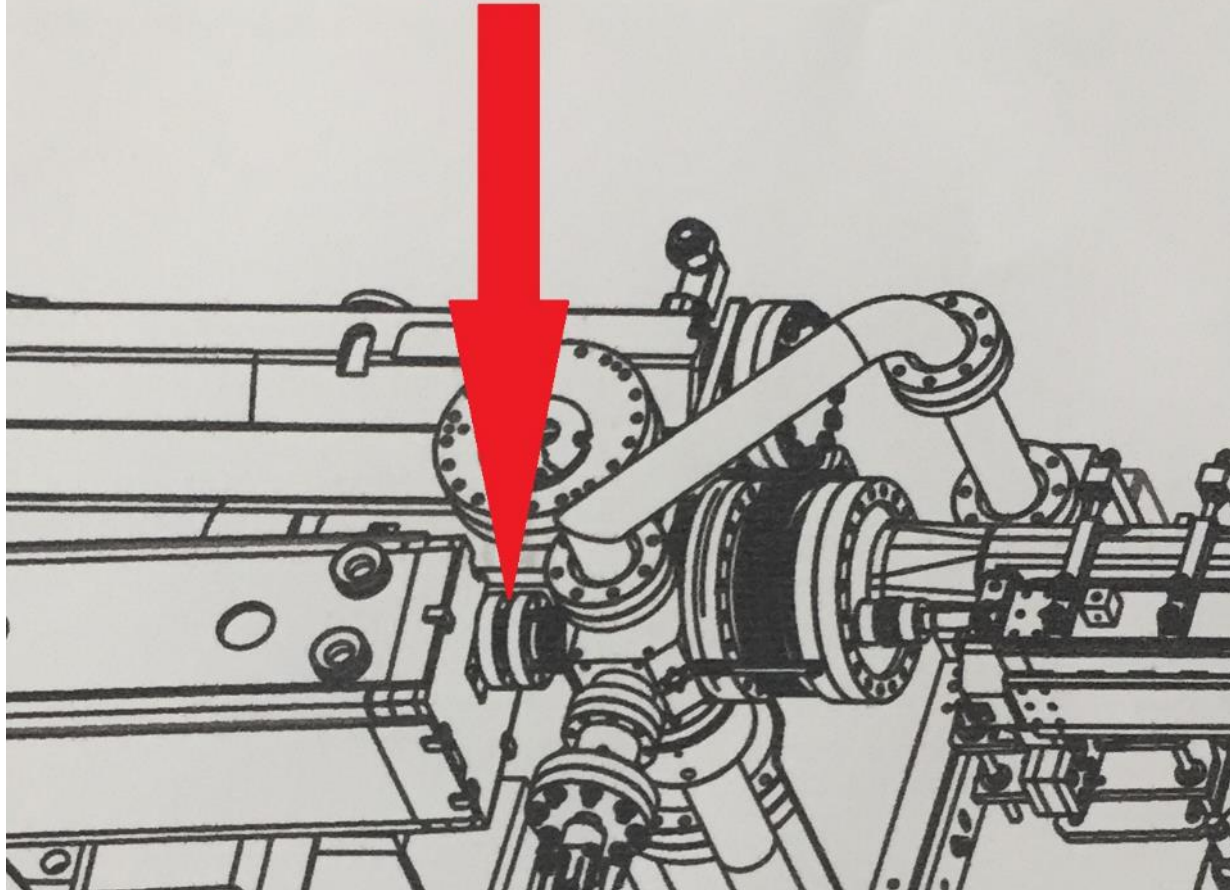
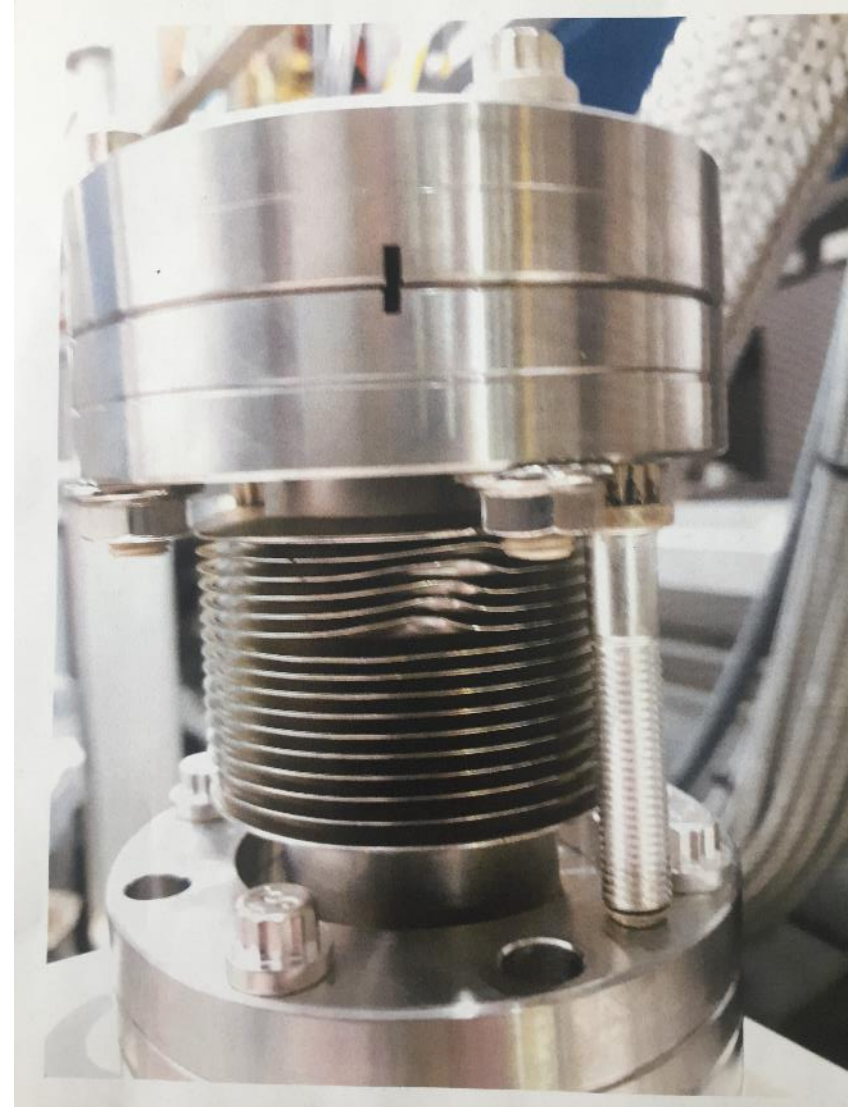
- VAC Group arrival at 6 AM to start wrapping / heat tape for bake out
- Spare bellows assembly located and installation started, after discovery of dented convolutions on downstream assembly.
- Wrapping completed and bake out started
- Plan still targets handover to AOP / MCR on Sunday evening

Dented convolutions on outboard side, underneath of compressed bellows (as-installed)

Extremely difficult to see with lead shielding overhead providing tight clearance or accessibility

- Immediately order and expedite replacement bellow assemblies unique to thick septum assembly. [Completed](#)
 - Increase concentration of technician base trained and certified to Rad Worker 2 level. [Pending](#)
