APS OPERATIONS AND SAFETY

GEORGE SRAJER

DEPUTY DIRECTOR, ADVANCED PHOTON SOURCE

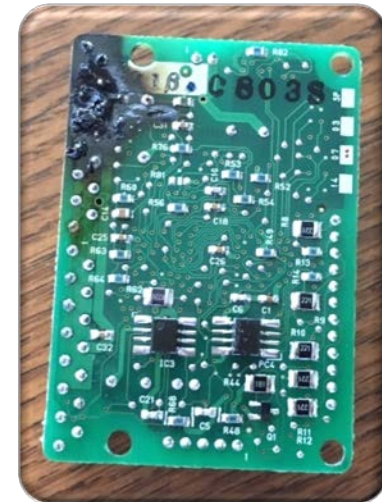
(Model #CRD5107P)

- 1-ID-E electrical equipment burn-up on 6/27/18; fact-finding was performed on 6/28
- It was later determined that a Vexta motor driver had failed and scorched

- Barricade area to prevent re-entry into the space
 - Turn off systems immediately
 - Check systems with a thermal imaging IR camera immediately (failed component may not be evidenced visually)

- Using IR camera, look for components operating at $>40^{\circ}\text{C}$ indicating a component is overheating/failing. (Normal operating temperature for a motor driver is 40°C .)

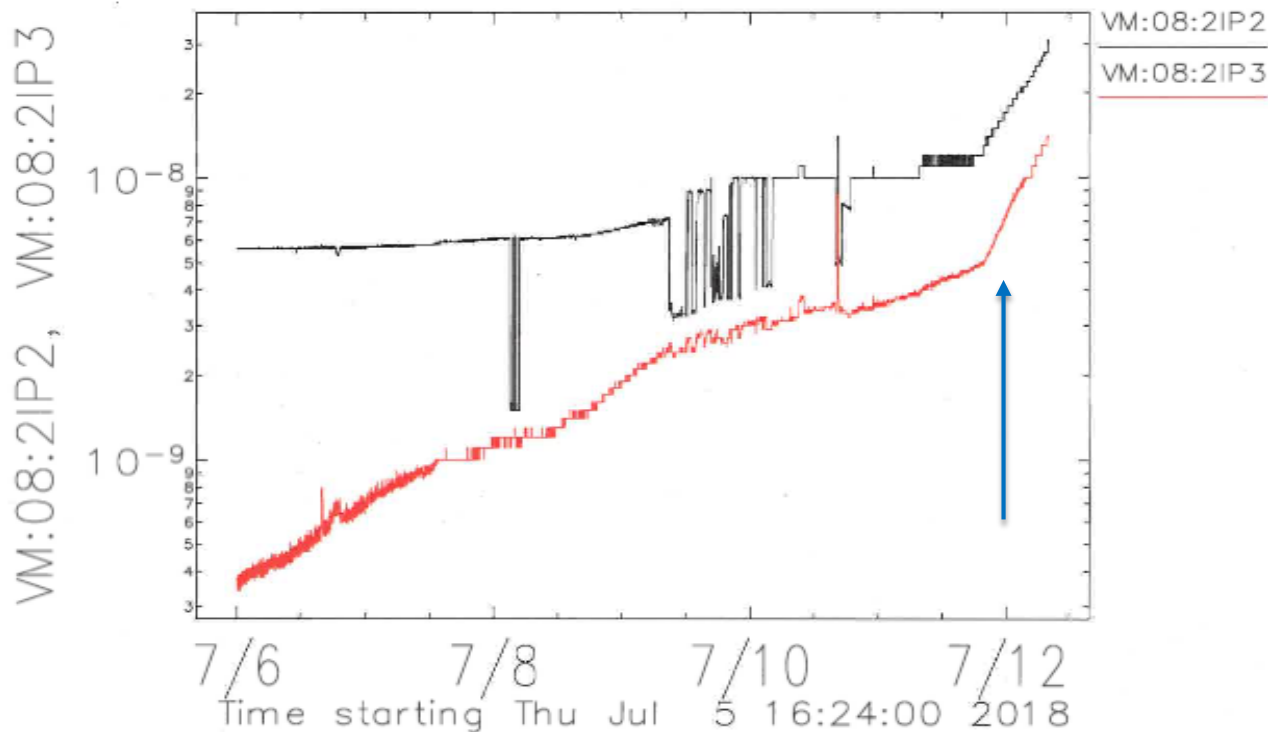
STORAGE RING SECTOR 8 VACUUM LEAK

- Early signs of trouble: July 5
 - Significant negative impact on lifetime and emittance
- Intent was to wait until July 16 for access during a machine studies/ intervention day
 - Vacuum started rapidly deteriorating on July 12, forcing intervention

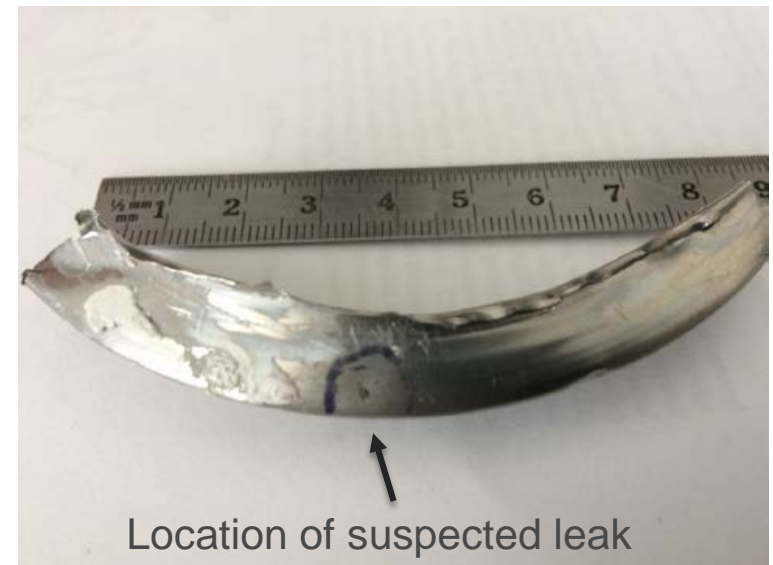
STORAGE RING SECTOR 8 VACUUM LEAK (CONT.)

- July 12 (noon): MOM group personnel entered storage ring
- Found the leak on the bellows to the 7-ID Front End exit port
 - An initial test with tape to see if leak could be sealed, plugged the leak
 - Leak further intensified and all the ion pumps tripped off while prepping and applying TorrSeal on the leak site
 - With vacuum approaching 10^{-3} Torr range, bellows replacement was warranted, requiring breaking storage ring vacuum

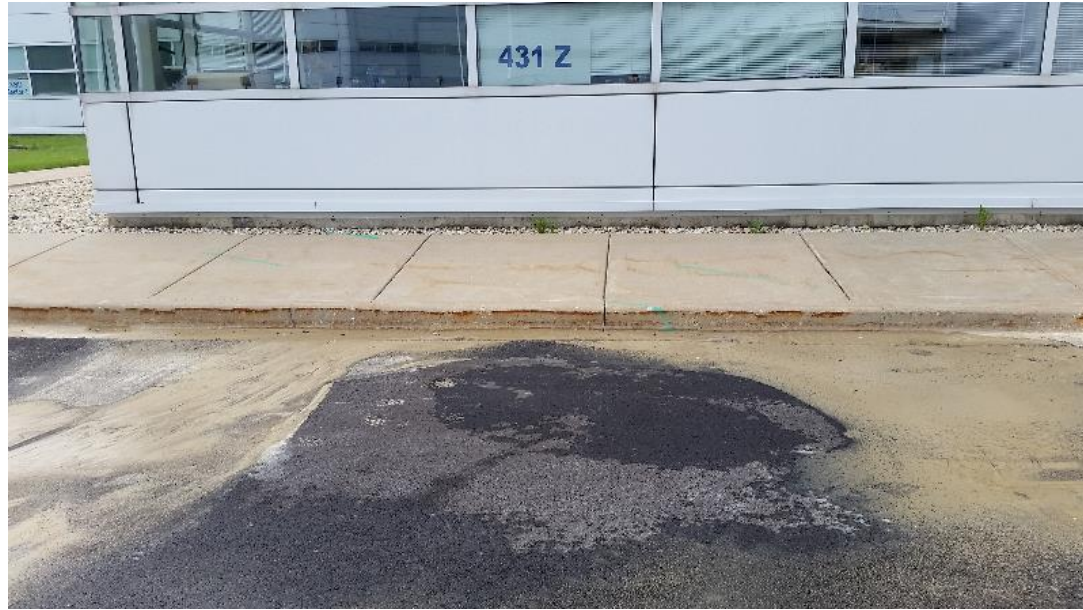
- Flood aftermath in parking lot next to LOM 431 Pentagon Z on June 13

APS AGING INFRASTRUCTURE: FIRE MAIN RUPTURE NEAR 431 PENTAGON Z

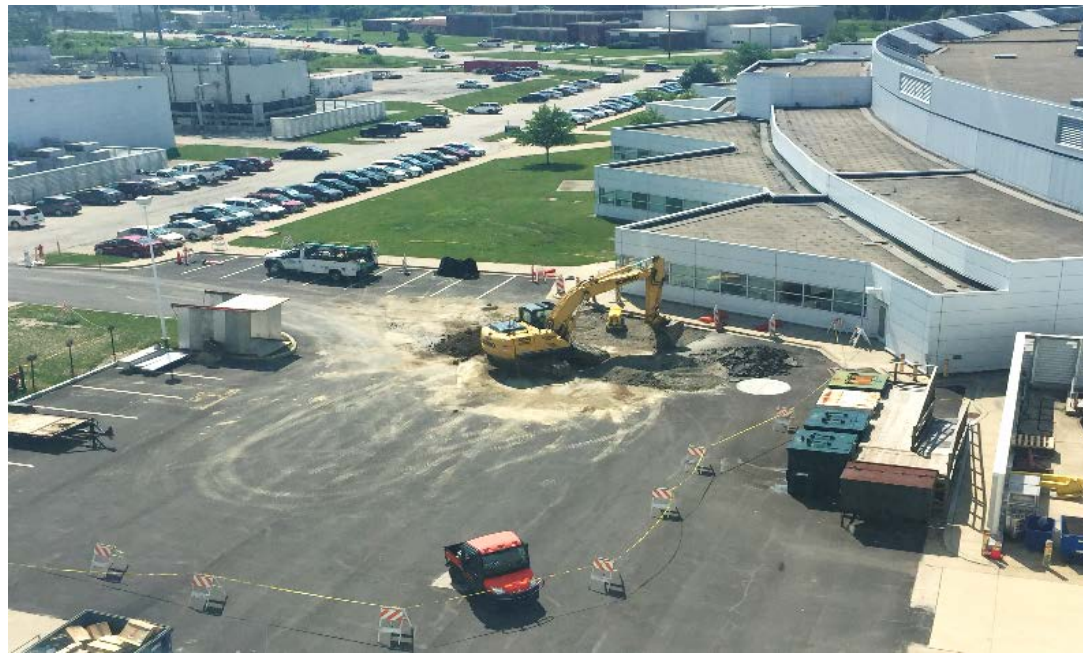
- Final compacting to grade after pressure and backflow testing of repaired 10-inch main as of June 18
